PARKS COMMISSION

AGENDA

Tuesday, May 2, 2023

Town of Berlin
Henry Park
 127 Flower Street
 Berlin, MD 21811

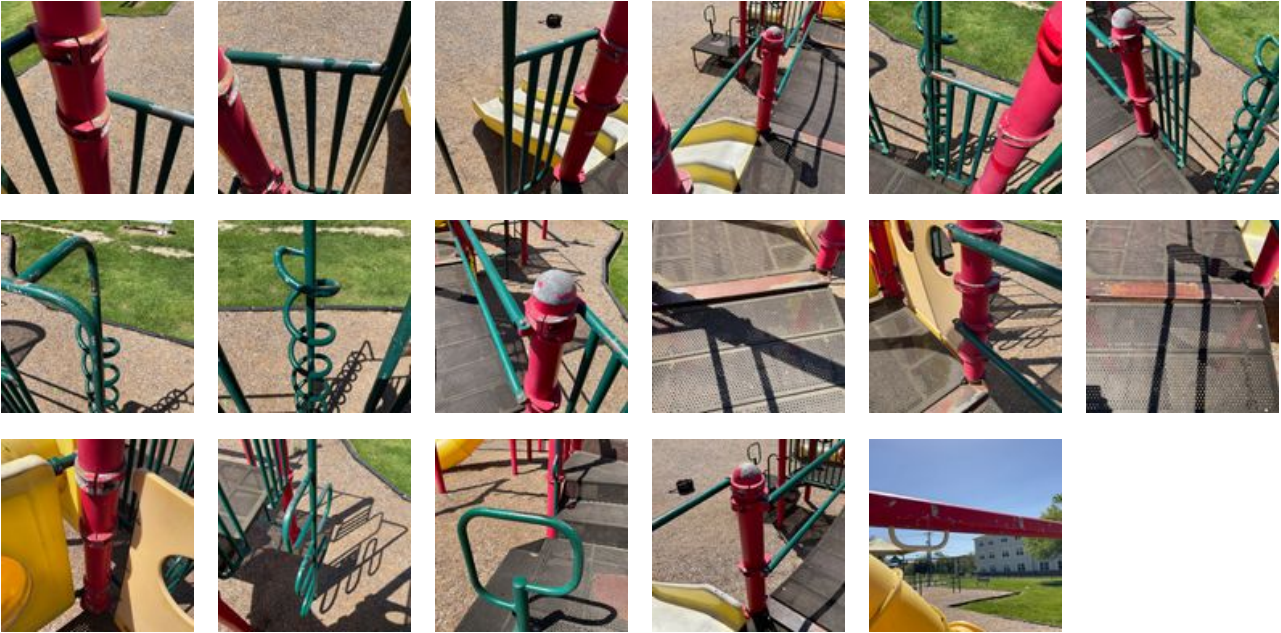
Worn - 5-12 Red and Yellow Unit

Part: Paint Reported By: Eric Patterson
Action: Paint Created On: 04/20/2023
Priority: 4
Comments: Paint is worn and rust is developing on metals throughout the unit.

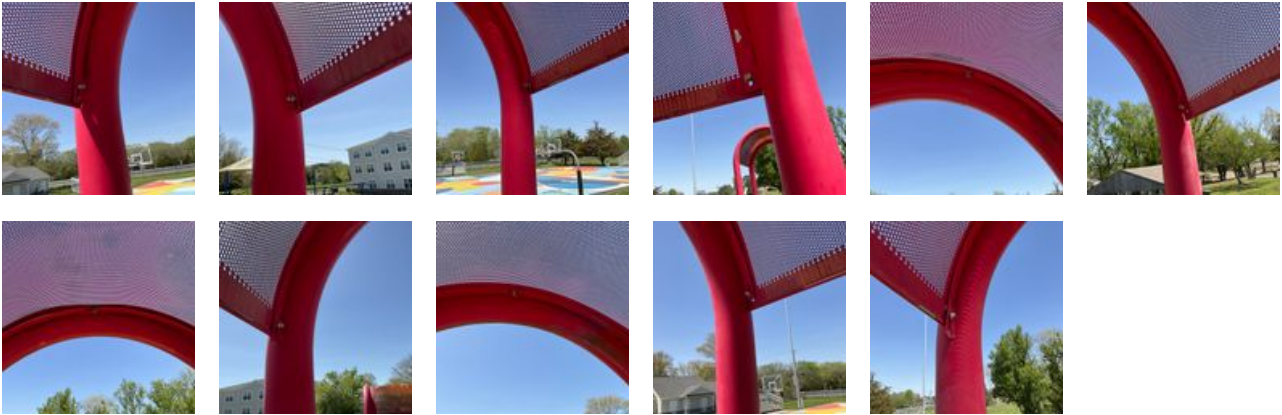
Hardware under the roof has more than two threads exposed. Loose bolt holding the roof. Bolt has been cut back and creates sharp edges.

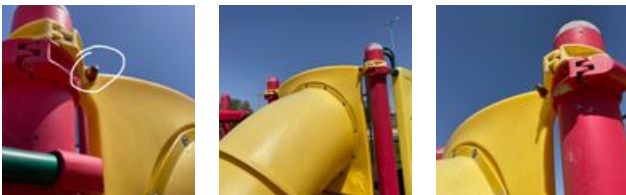
Entanglement - 5-12 Red and Yellow Unit

Part: Hardware
Action: Replace
Priority: 2
Comments:

Hardware on the hood of the slide create entanglement hazards.

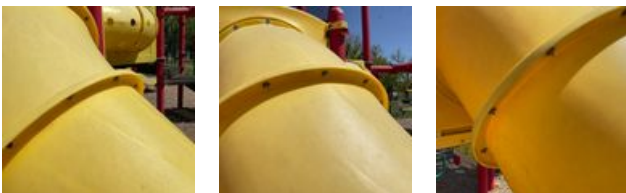
Non Compliant - 5-12 Red and Yellow Unit

Part: Hardware
Action: Correct
Priority: 4
Comments:

Bolts on the tube slide have more than two threads exposed.
