# **PARKS COMMISSION**

## **AGENDA**

**Tuesday, September 30, 2025**  
**4:30 PM**

Parks Commission  
Meeting Minutes  
Tuesday, July 1, 2025

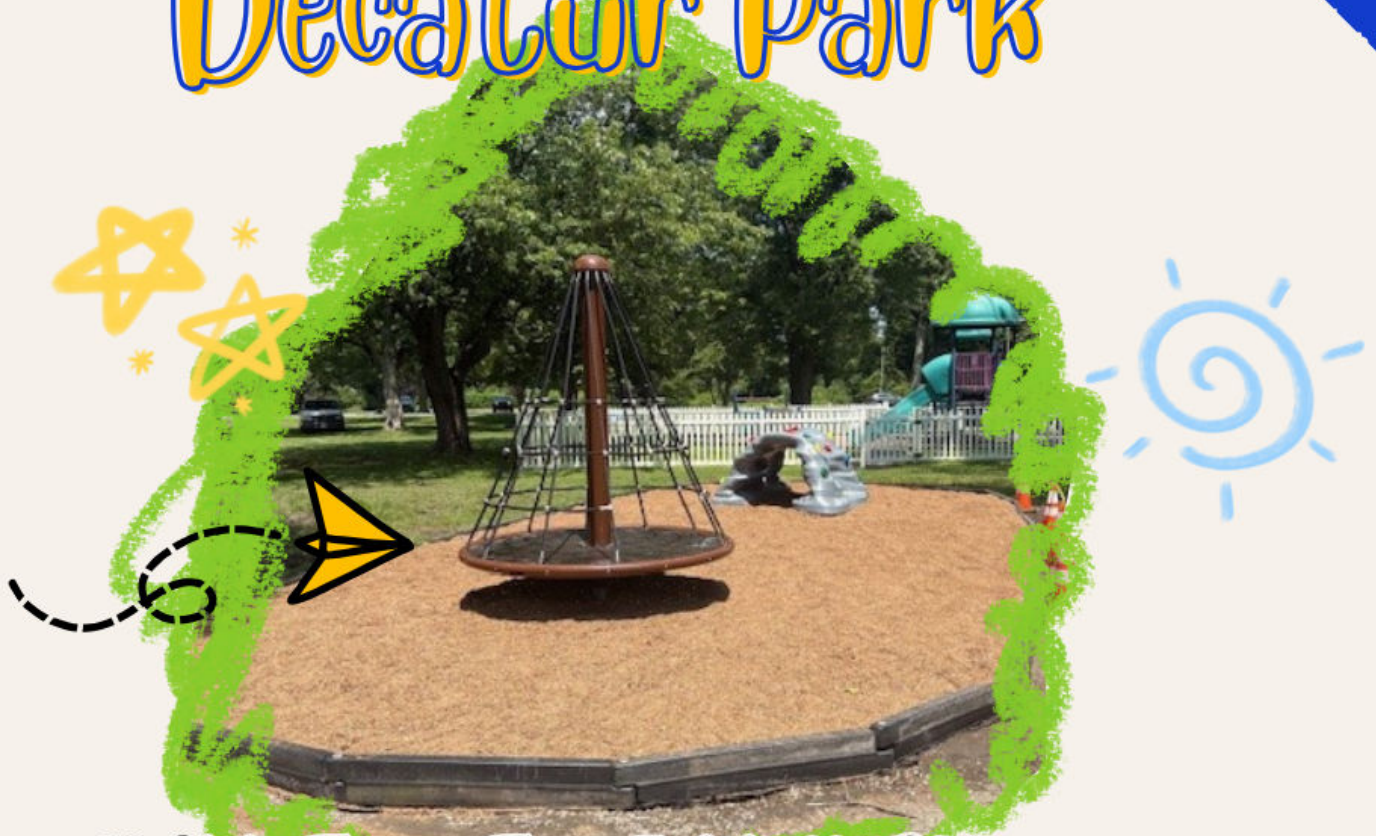
# Stephen Decatur Park

## NEW Tree Top & Wall Climber

After a long delay, the new equipment is now ready for use!  
Please note that cones are still placed along the path due to standing water.  
Enter the play area from the pavilion or playground side.  
Public Works plans to improve the landscaping in the coming weeks.

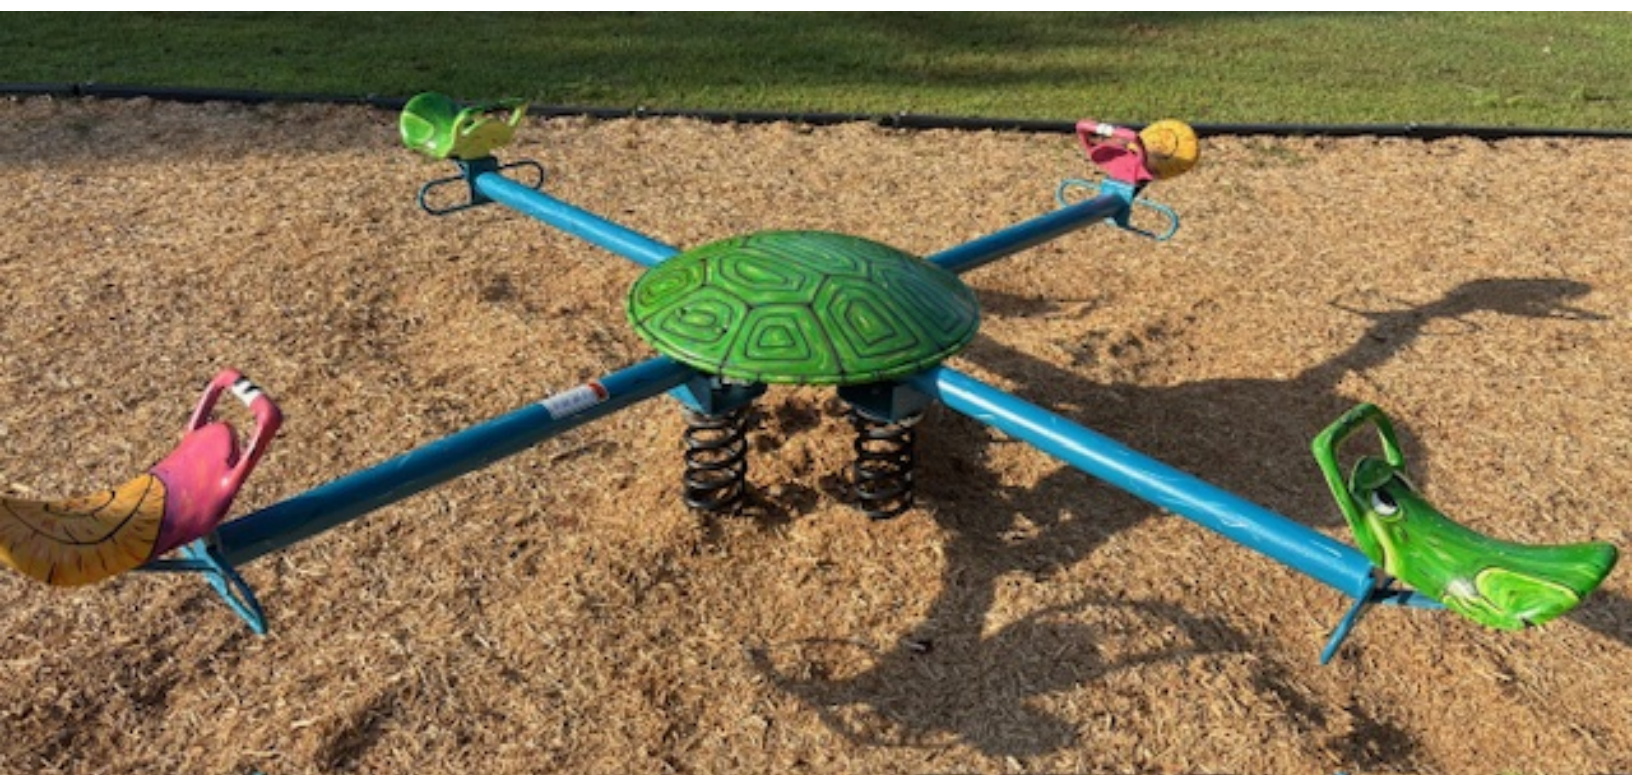
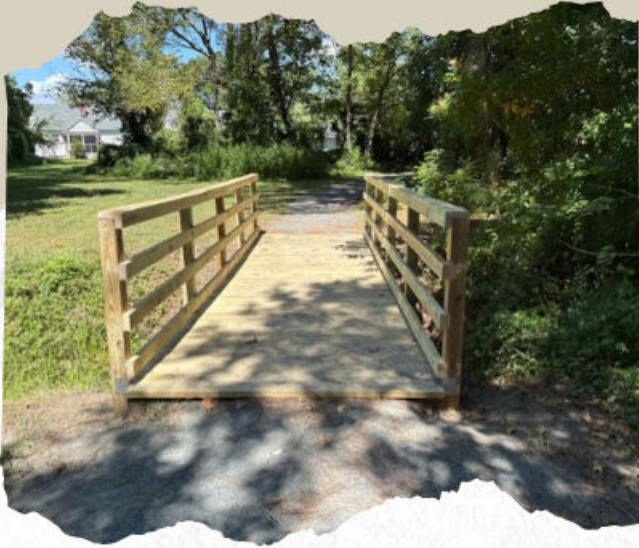
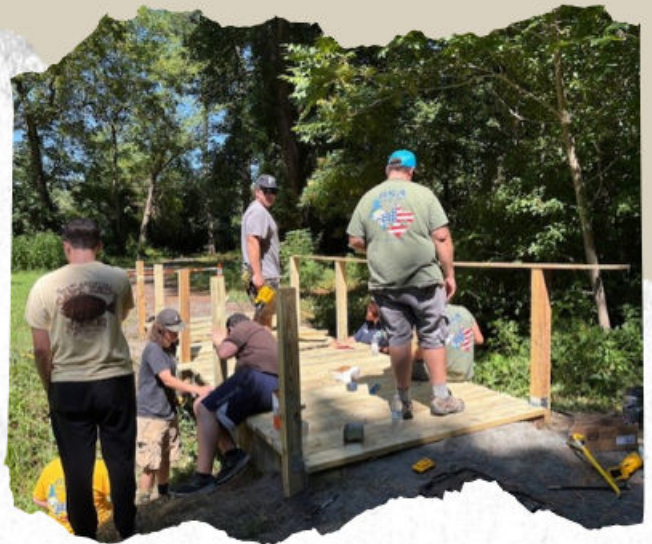
## Stephen Decatur Park Nature Trail Bridge Restoration

A big thank you to Parker Gill,  
members of Life Scout Troop 26I,  
as well as the Town of Berlin  
Public Works Department for their  
dedication and hard work in  
repairing the natural trail  
bridges at Stephen Decatur Park!
